Challenges and Potentials of Retrofitting
Masonry Non-Engineered Construction in
Indonesia(Dissertation_全文)

**A Dissertation Submitted for the Fulfillment of
Doctoral Program
in Global Environmental Studies**

**Graduate School of Global Environmental Studies
Kyoto University
Japan**

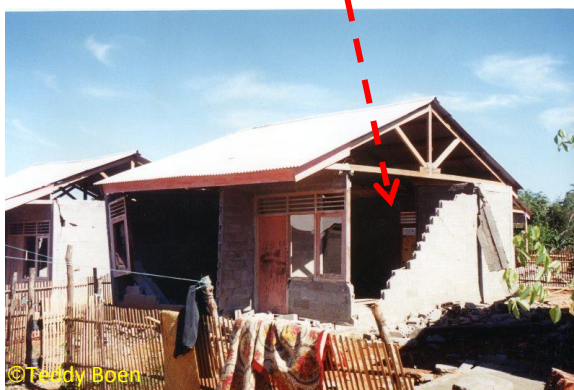
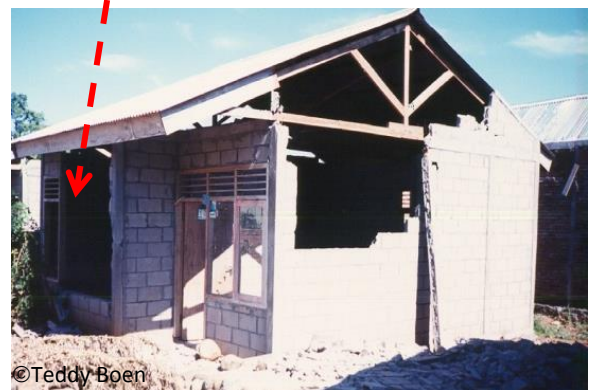
Figure 77 – Actual Damage – Bengkulu Earthquake (2000)

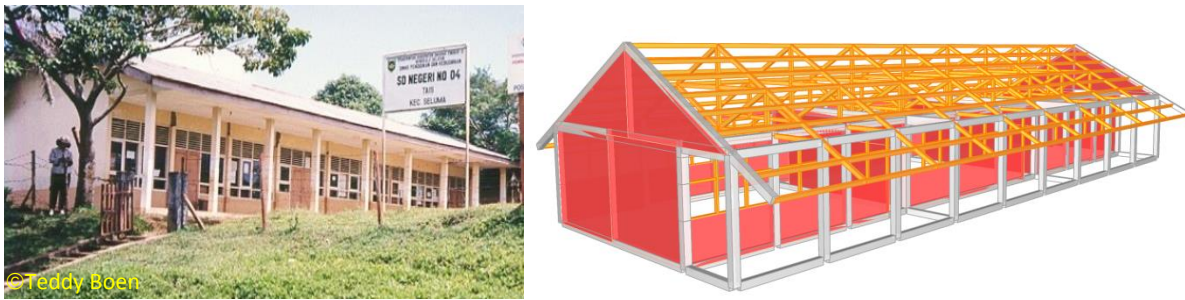
Figure 78 – Actual School Building and 3D Model for Analysis

The analysis is elastic using response spectrum based on the Indonesian Seismic Code 2012 and ASCE7-10 Table 12.2-1 for Bengkulu area (Hard soil; PGA = 0.42g; Importance Factor = 1.5, R = 1.5).

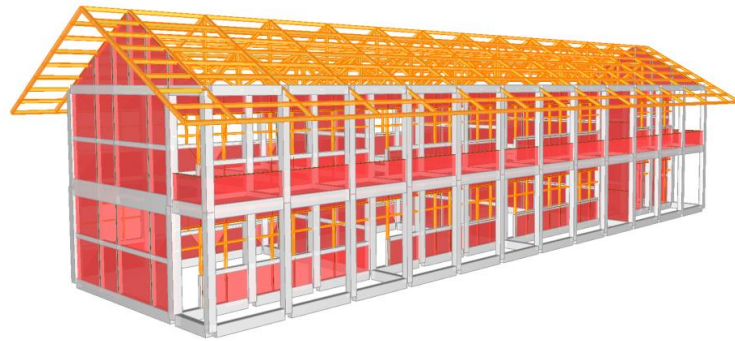
Figure 81 – 3D Model of Two Stories School Building with Confinement

The analysis is elastic using response spectrum based on the Indonesian Seismic Code 2012 and ASCE7-10 Table 12.2-1 for Bengkulu area (Hard soil; PGA = 0.42g; Importance Factor = 1.5, R = 1.5).

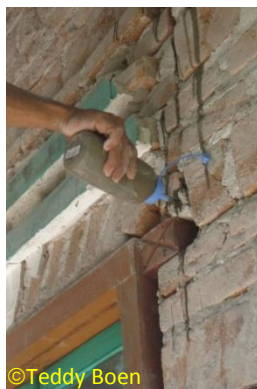
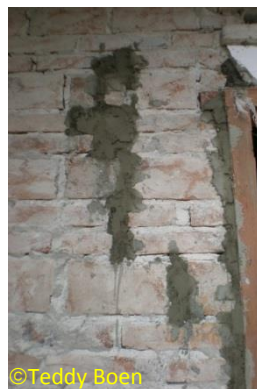
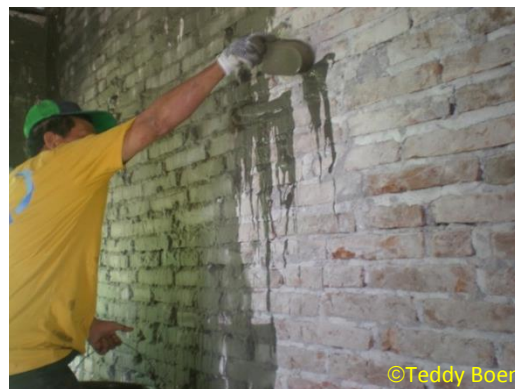
Figure 90 – Cracks are sealed with Cement - Sand Mortar; Walls are sprayed with Cement-Water

2. The cracks are sealed with cement and sand mortar (Figure 90). Spray the walls with water if the mortar consists of sand and cement. However, if the mortar of the existing walls consist of lime and sand or lime, red-brick powder and sand, without cement, it is better to inject cement water into the mortar.

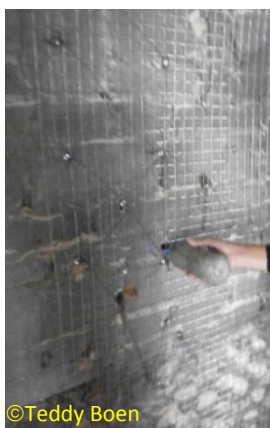
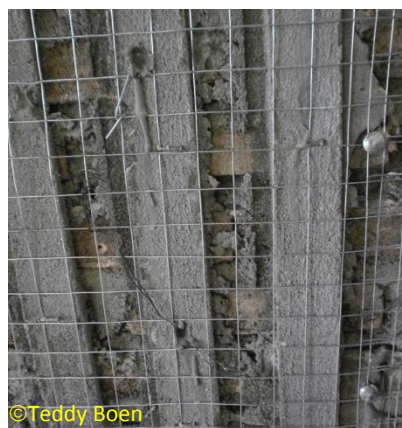
Figure 97 – Grouting of Drill Holes Using Cement Paste

6. Grout the hole using cement paste as can be seen in Figure 97.

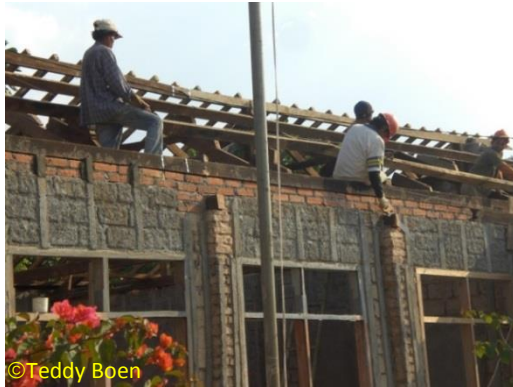
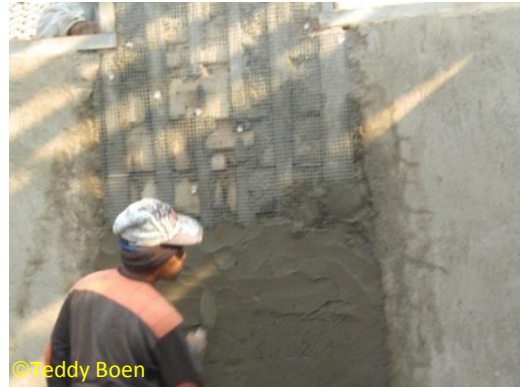
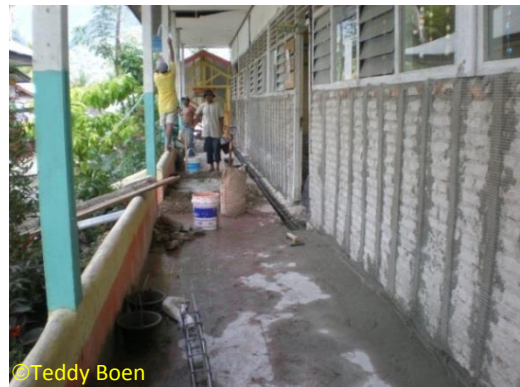
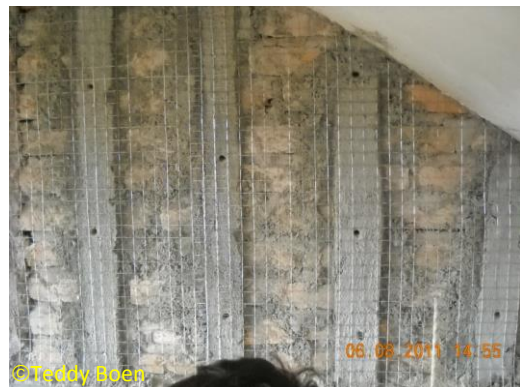
Figure 99 – Example of Retrofitting Buildings using Wire Mesh

Such retrofitting method using ferrocement as strengthening layers was used when retrofitting two school buildings in Bandung, i.e. SDN Cirateun Kulon II in 2006 and SDN

Padasuka II Soreang in 2007 (United Nations Centre for Regional Development (UNCRD) & Center for Disaster Mitigation (CDM) ITB, 2007). The projects were a collaborative project to reduce the vulnerability of those existing school buildings in the corridor of School Earthquake Safety Initiative (SESI) project. After retrofitting, those school buildings survived the September 2, 2009, West Java earthquake without significant cracks.

Many retrofitting projects were also done using this proposed retrofitting method, especially after the September 30, 2009 West Sumatra earthquake, many school buildings and also an engineered building were retrofitted using this method.

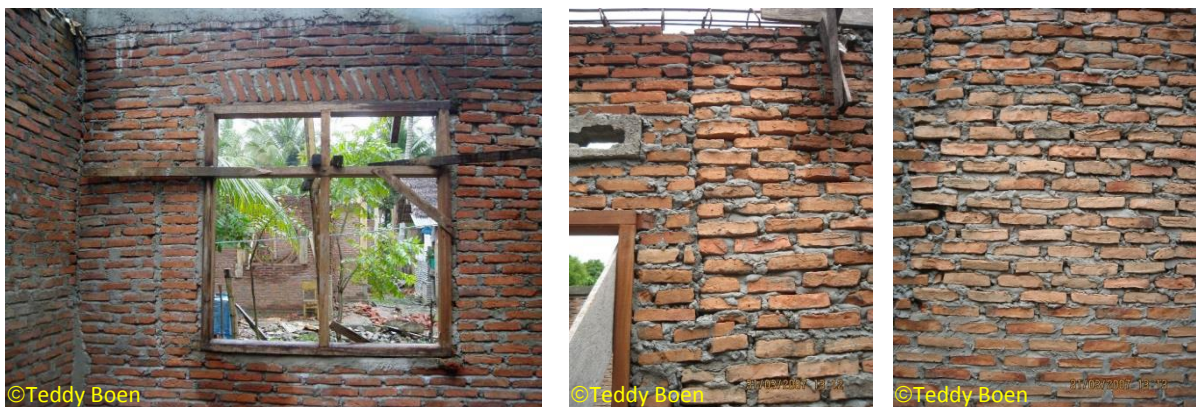
Figure 102 – Poor Workmanship Non-uniformities in Actual Brick Walls

Based on observations for the past 40 years, surveys and tests which have been conducted by various agencies as mentioned in Chapter 3.6.1, in Indonesia, there are many variation of bricks dimension. The quality of brick-works also vary, from good enough until poorly brick-work, as can be seen in Figure 102.

Due to numerous uncertainties in the brick wall; such as the quality of brick, mortar's strength, workmanship, non-uniformity of mortar thickness in the joints, curing of the test piece, test procedure, method of loading and handling of specimen, etc. a quantitative analysis especially applying very sophisticated methods of analysis is considered as a waste of time and energy as can be seen in Figure 102. Application of simple algebra and strength

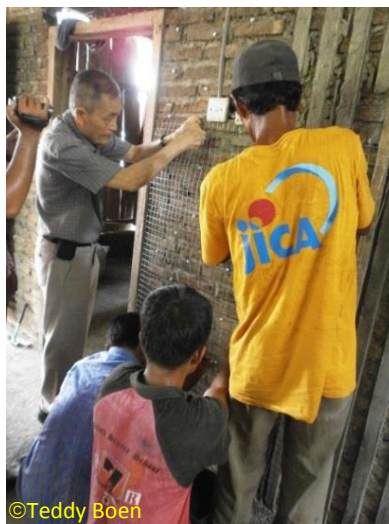
Installation of Wire Mesh, Tie to Umbrella-Head-Roofing-Nail

Figure 135 shows the sequence of retrofitting works in Tanjung Basung. The detail explanation of this proposed retrofitting method can be seen in Chapter 5.3 on page 122.

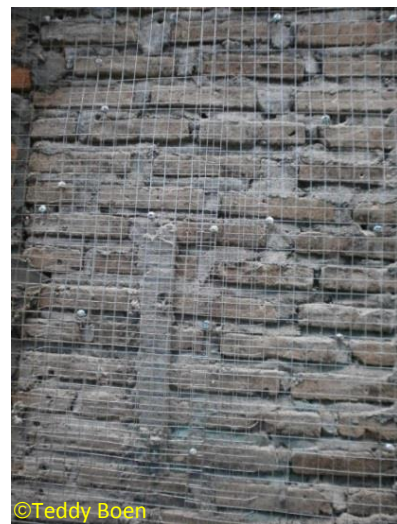
Wire Mesh Installed and Fastened to Top of Umbrella-Head-Roofing-Nail

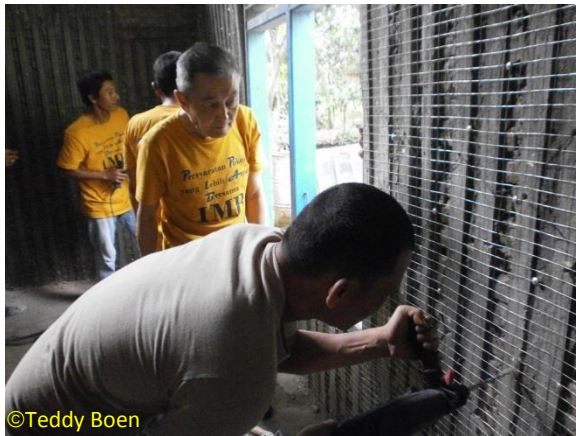
Drilling the Walls for Stitching

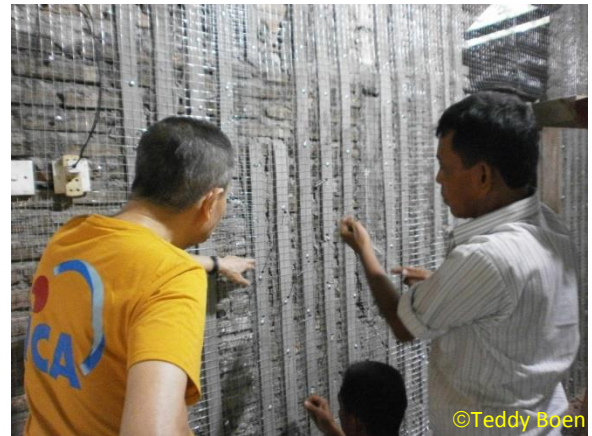
Stitching the Inside and Outside Wire Mesh

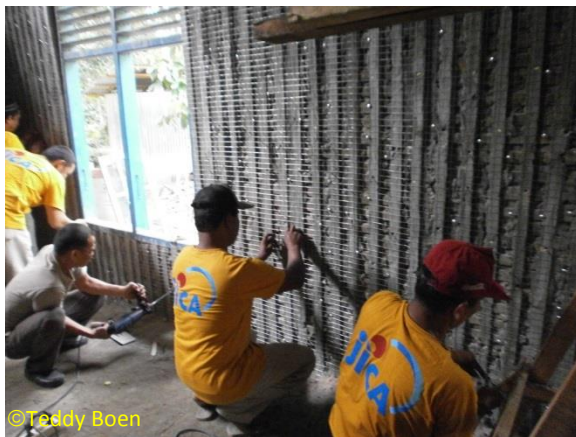
Trained Local Masons Stitching the Inside and Outside Wire Mesh

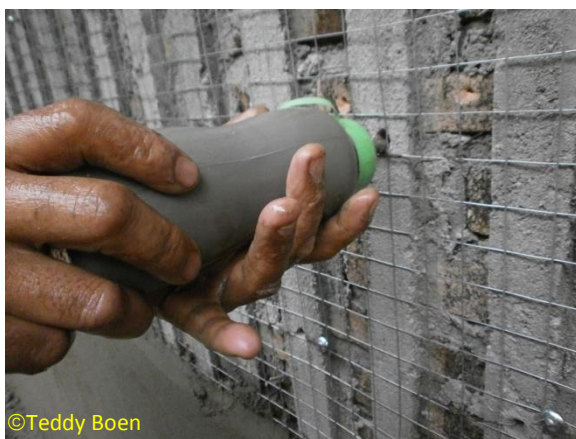
Grouting of Drill Holes using Cement Paste

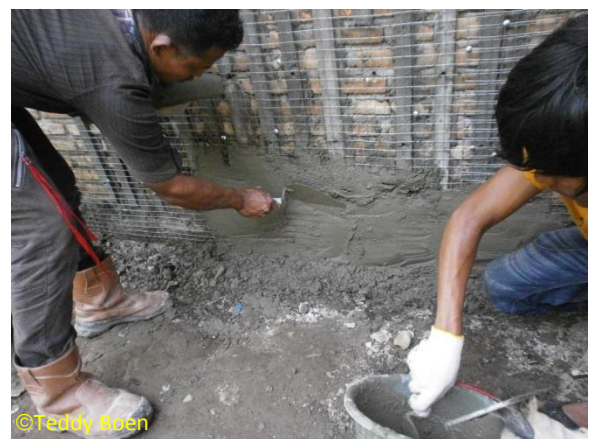
Re-plastering the Wall

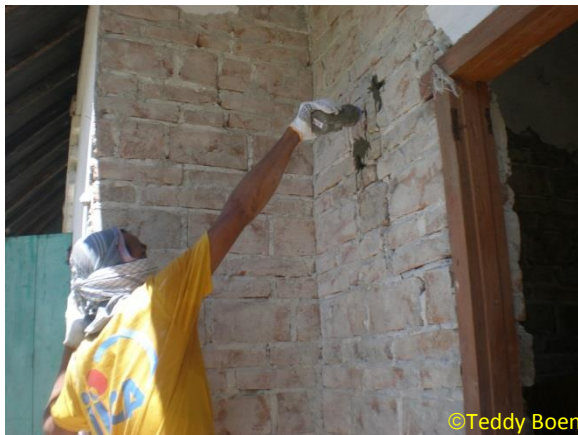
Sealing the Cracks with Cement - Sand Mortar

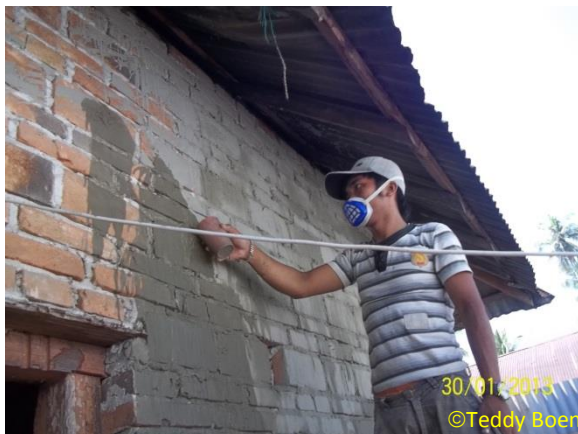
Spraying Walls with Cement-Water

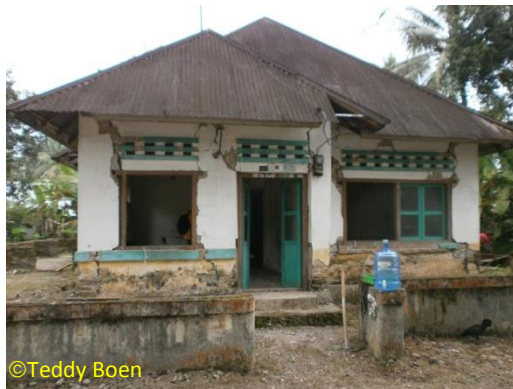
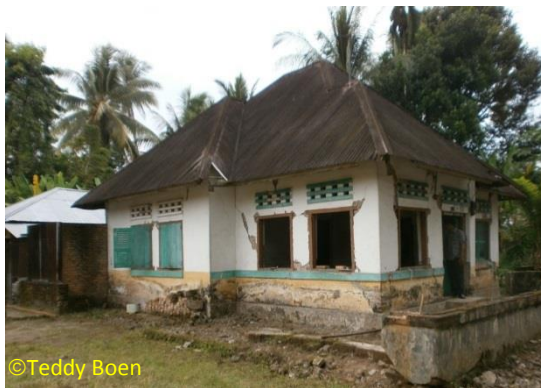
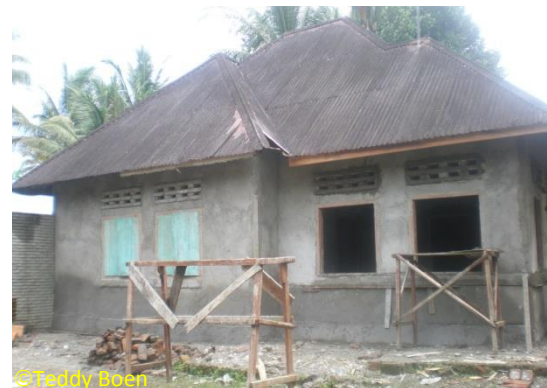
Figure 139 – Before and After Retrofitting, House in Gadur

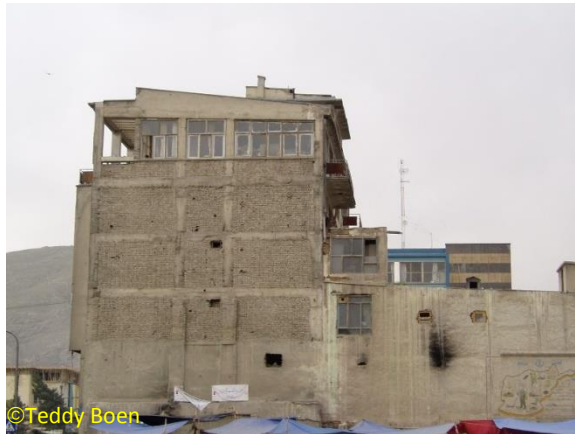
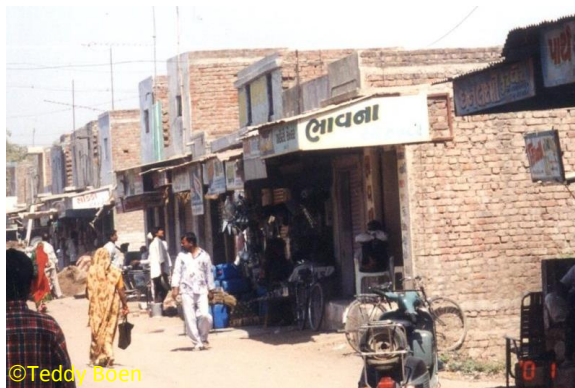
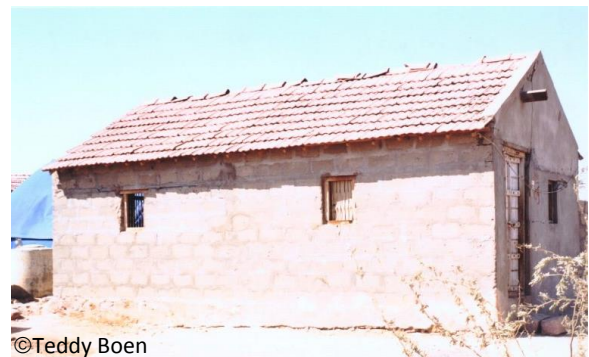
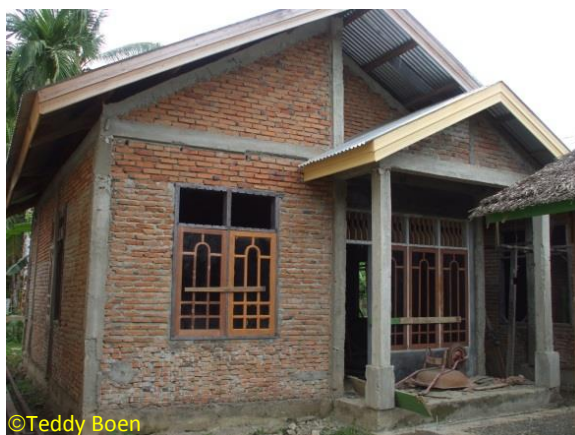
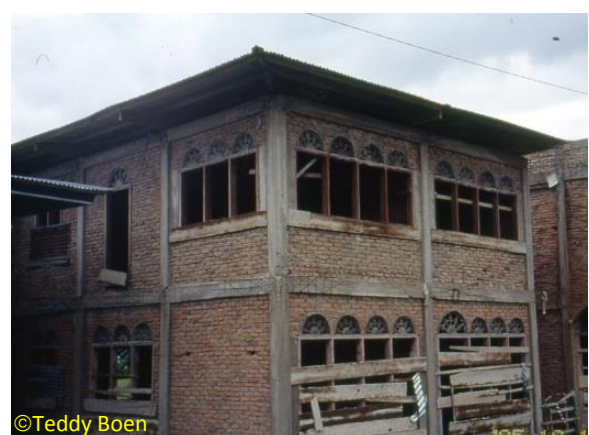
Figure 140 – Non-Engineered Construction in Developing Countries

Since the retrofitting method is simple, affordable, replicable and can be implemented by self-help construction, it can also be applied in other earthquake prone developing countries such as Bangladesh, India, Myanmar, Nepal, Pakistan that have some similarities in non-engineered masonry construction as that of Indonesia, which is shown in Figure 140 (Center for Disaster Mitigation Institute Technology Bandung, 2011):

1. Design intervention by owner
2. Building owner are private
3. Almost all types of materials and workers are available
4. No supervision by other parties, supervised by owner themselves
5. Using small concrete mixer or mixed by hand for concreting
6. The buildings function as residential
7. Use strip foundation
8. Half-brick or one-brick wall thickness
9. Use Portland cement for wall plaster
10. Use Portland cement as cement material for concreting
11. No training for the workers
